## TECHNICAL MEMORANDUM

(6) FATIGUE LIFE  
OF  
IWRC WIRE ROPE.

Lab. Project 9300-54, Technical Memorandum #4

MATERIAL SCIENCES DIVISION

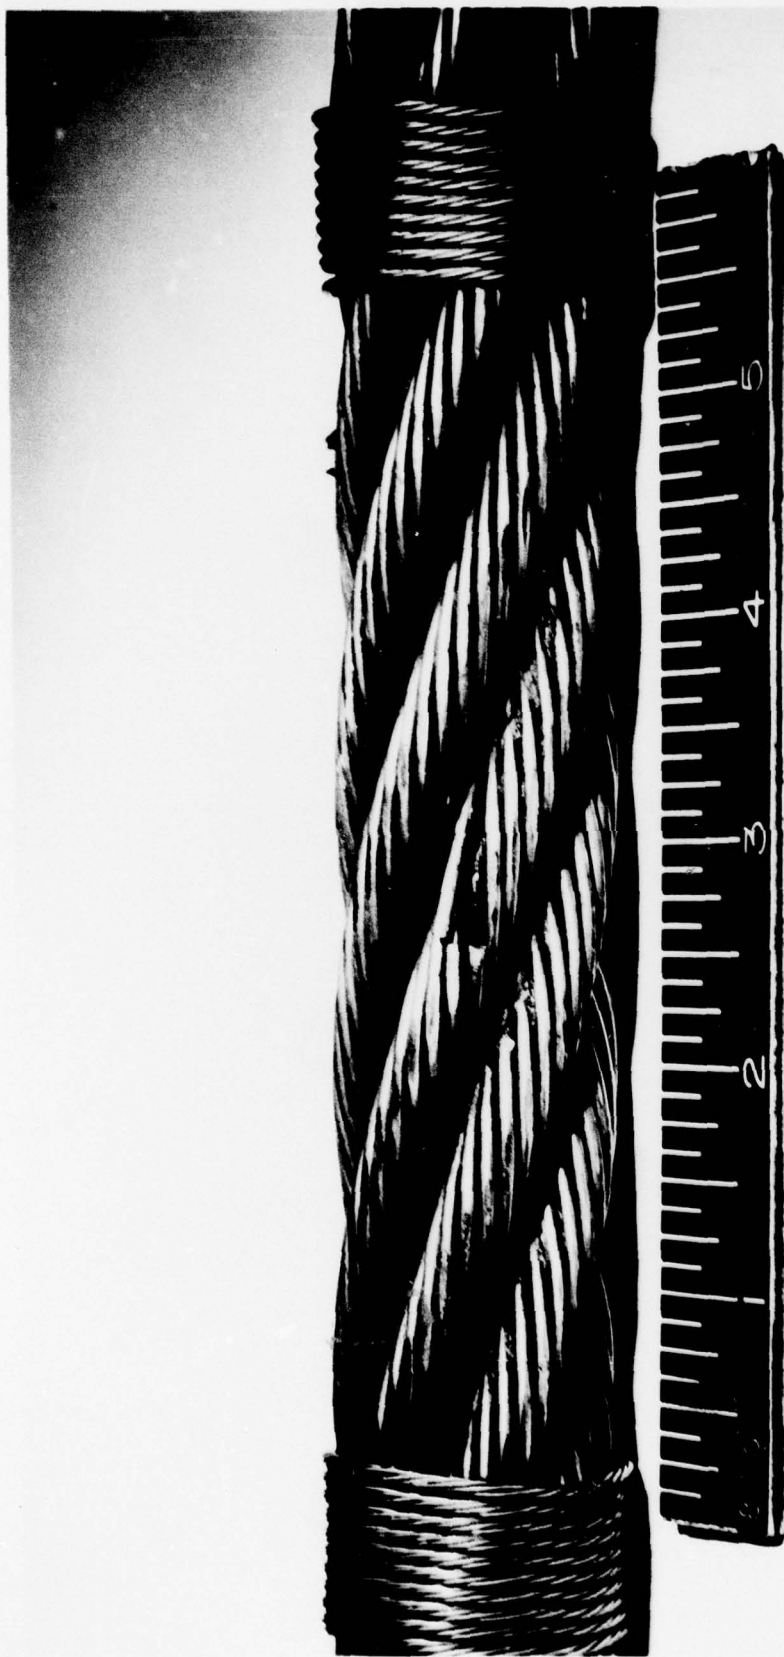
PHOTO 121198-3

FIGURE 3 - INITIAL BREAK AND WORN AREAS ON  
1 1/2" 6x19 (LPG) WIRE ROPE, AFTER  
1,000,000 CYCLES OF OPERATION

5. At approximately 1,000,000 cycles of operation, the first sign of failure was noted. One outer wire on the side of the rope making contact with the sheave groove broke within the one-foot length which alternately contacted and left the bottom portion of the sheave. The test was continued, and upon examination at 1,134,848 cycles two more wires had broken on the side of the rope making contact with the sheave groove within the one-foot length which alternately contacted and left the top portion of the sheave. Photographs of these wire breaks are shown in Figures (3), (4) and (5). Examination of the rope after disassembly revealed that none of the inner wires had broken during the test.
